# Resin Infiltration Technique: A Case Report of Minimally Invasive Treatment of White Spot Lesions

Lee, Tina M.; Blatz, Markus B.  
University of Pennsylvania School of Dental Medicine

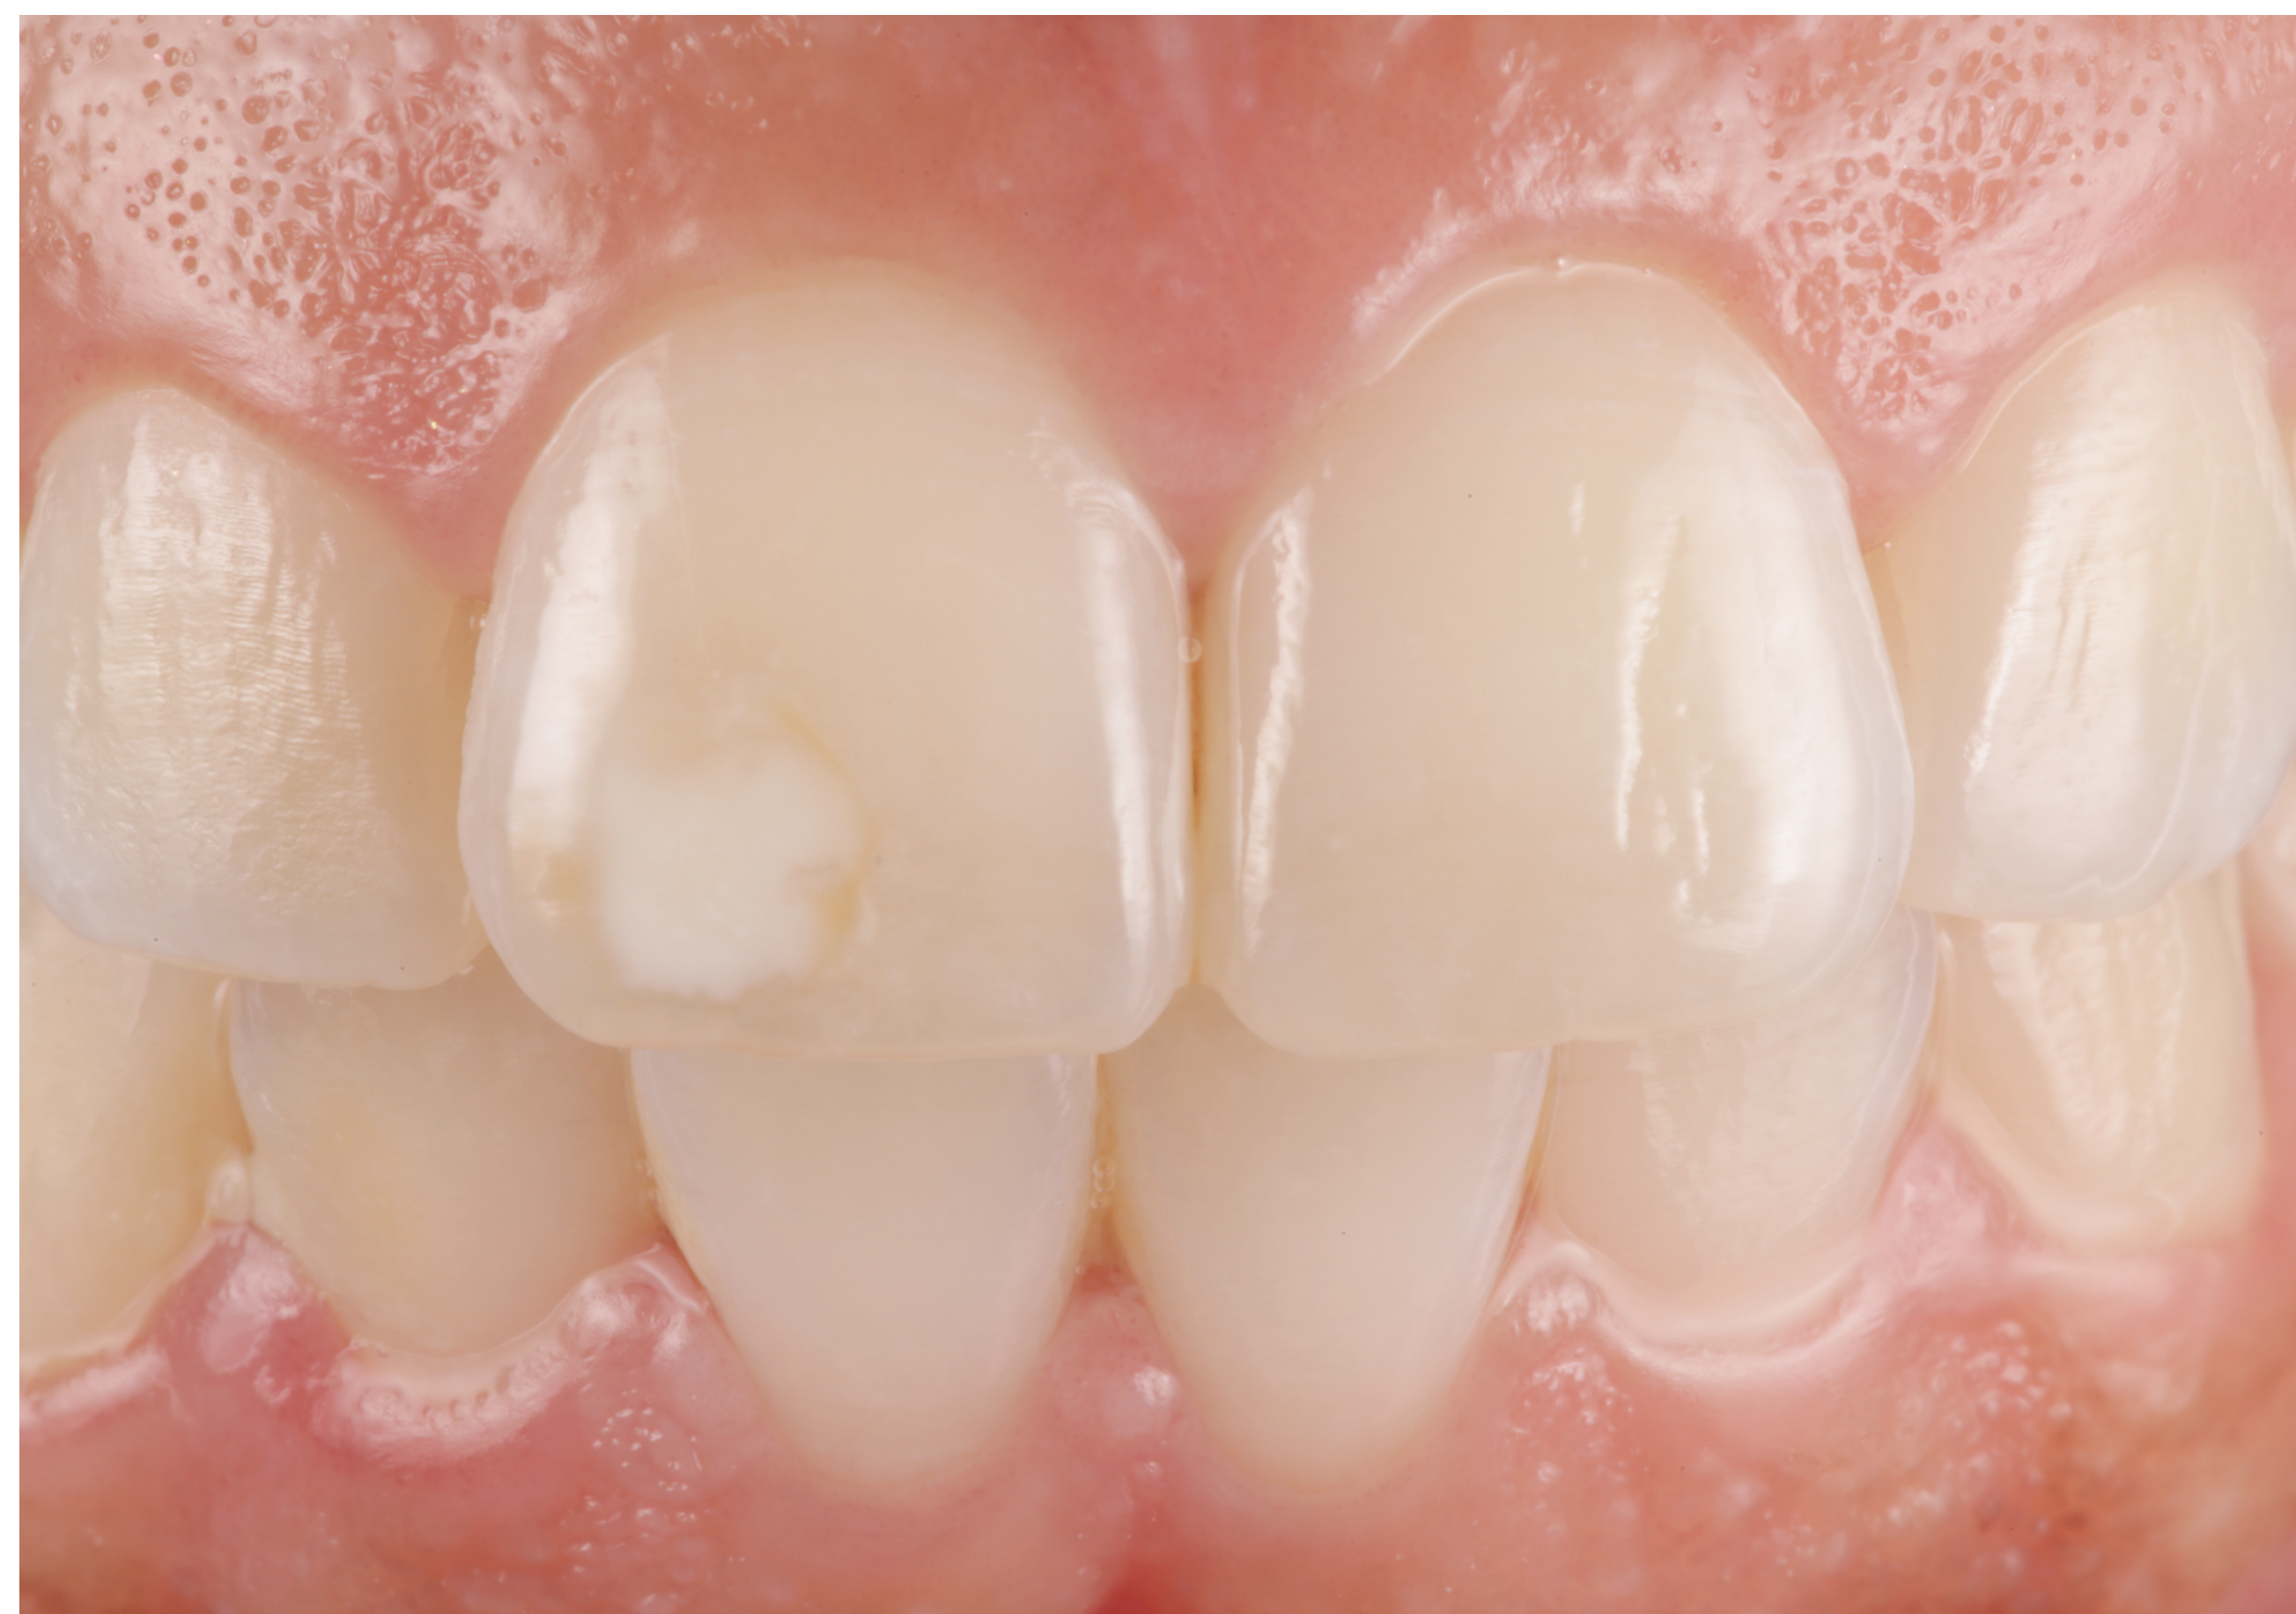
Figure 1: 43 year-old female patient presents to Penn Dental Medicine with an asymmetrical white spot lesion on the mid-incisal third of #8 facial surface.

Lesion treated via resin infiltration technique following manufacture instructions: etch with 15% hydrochloric acid gel, dry with ethanol, infiltrate with provided resin. Photographic records taken before and immediately after treatment.

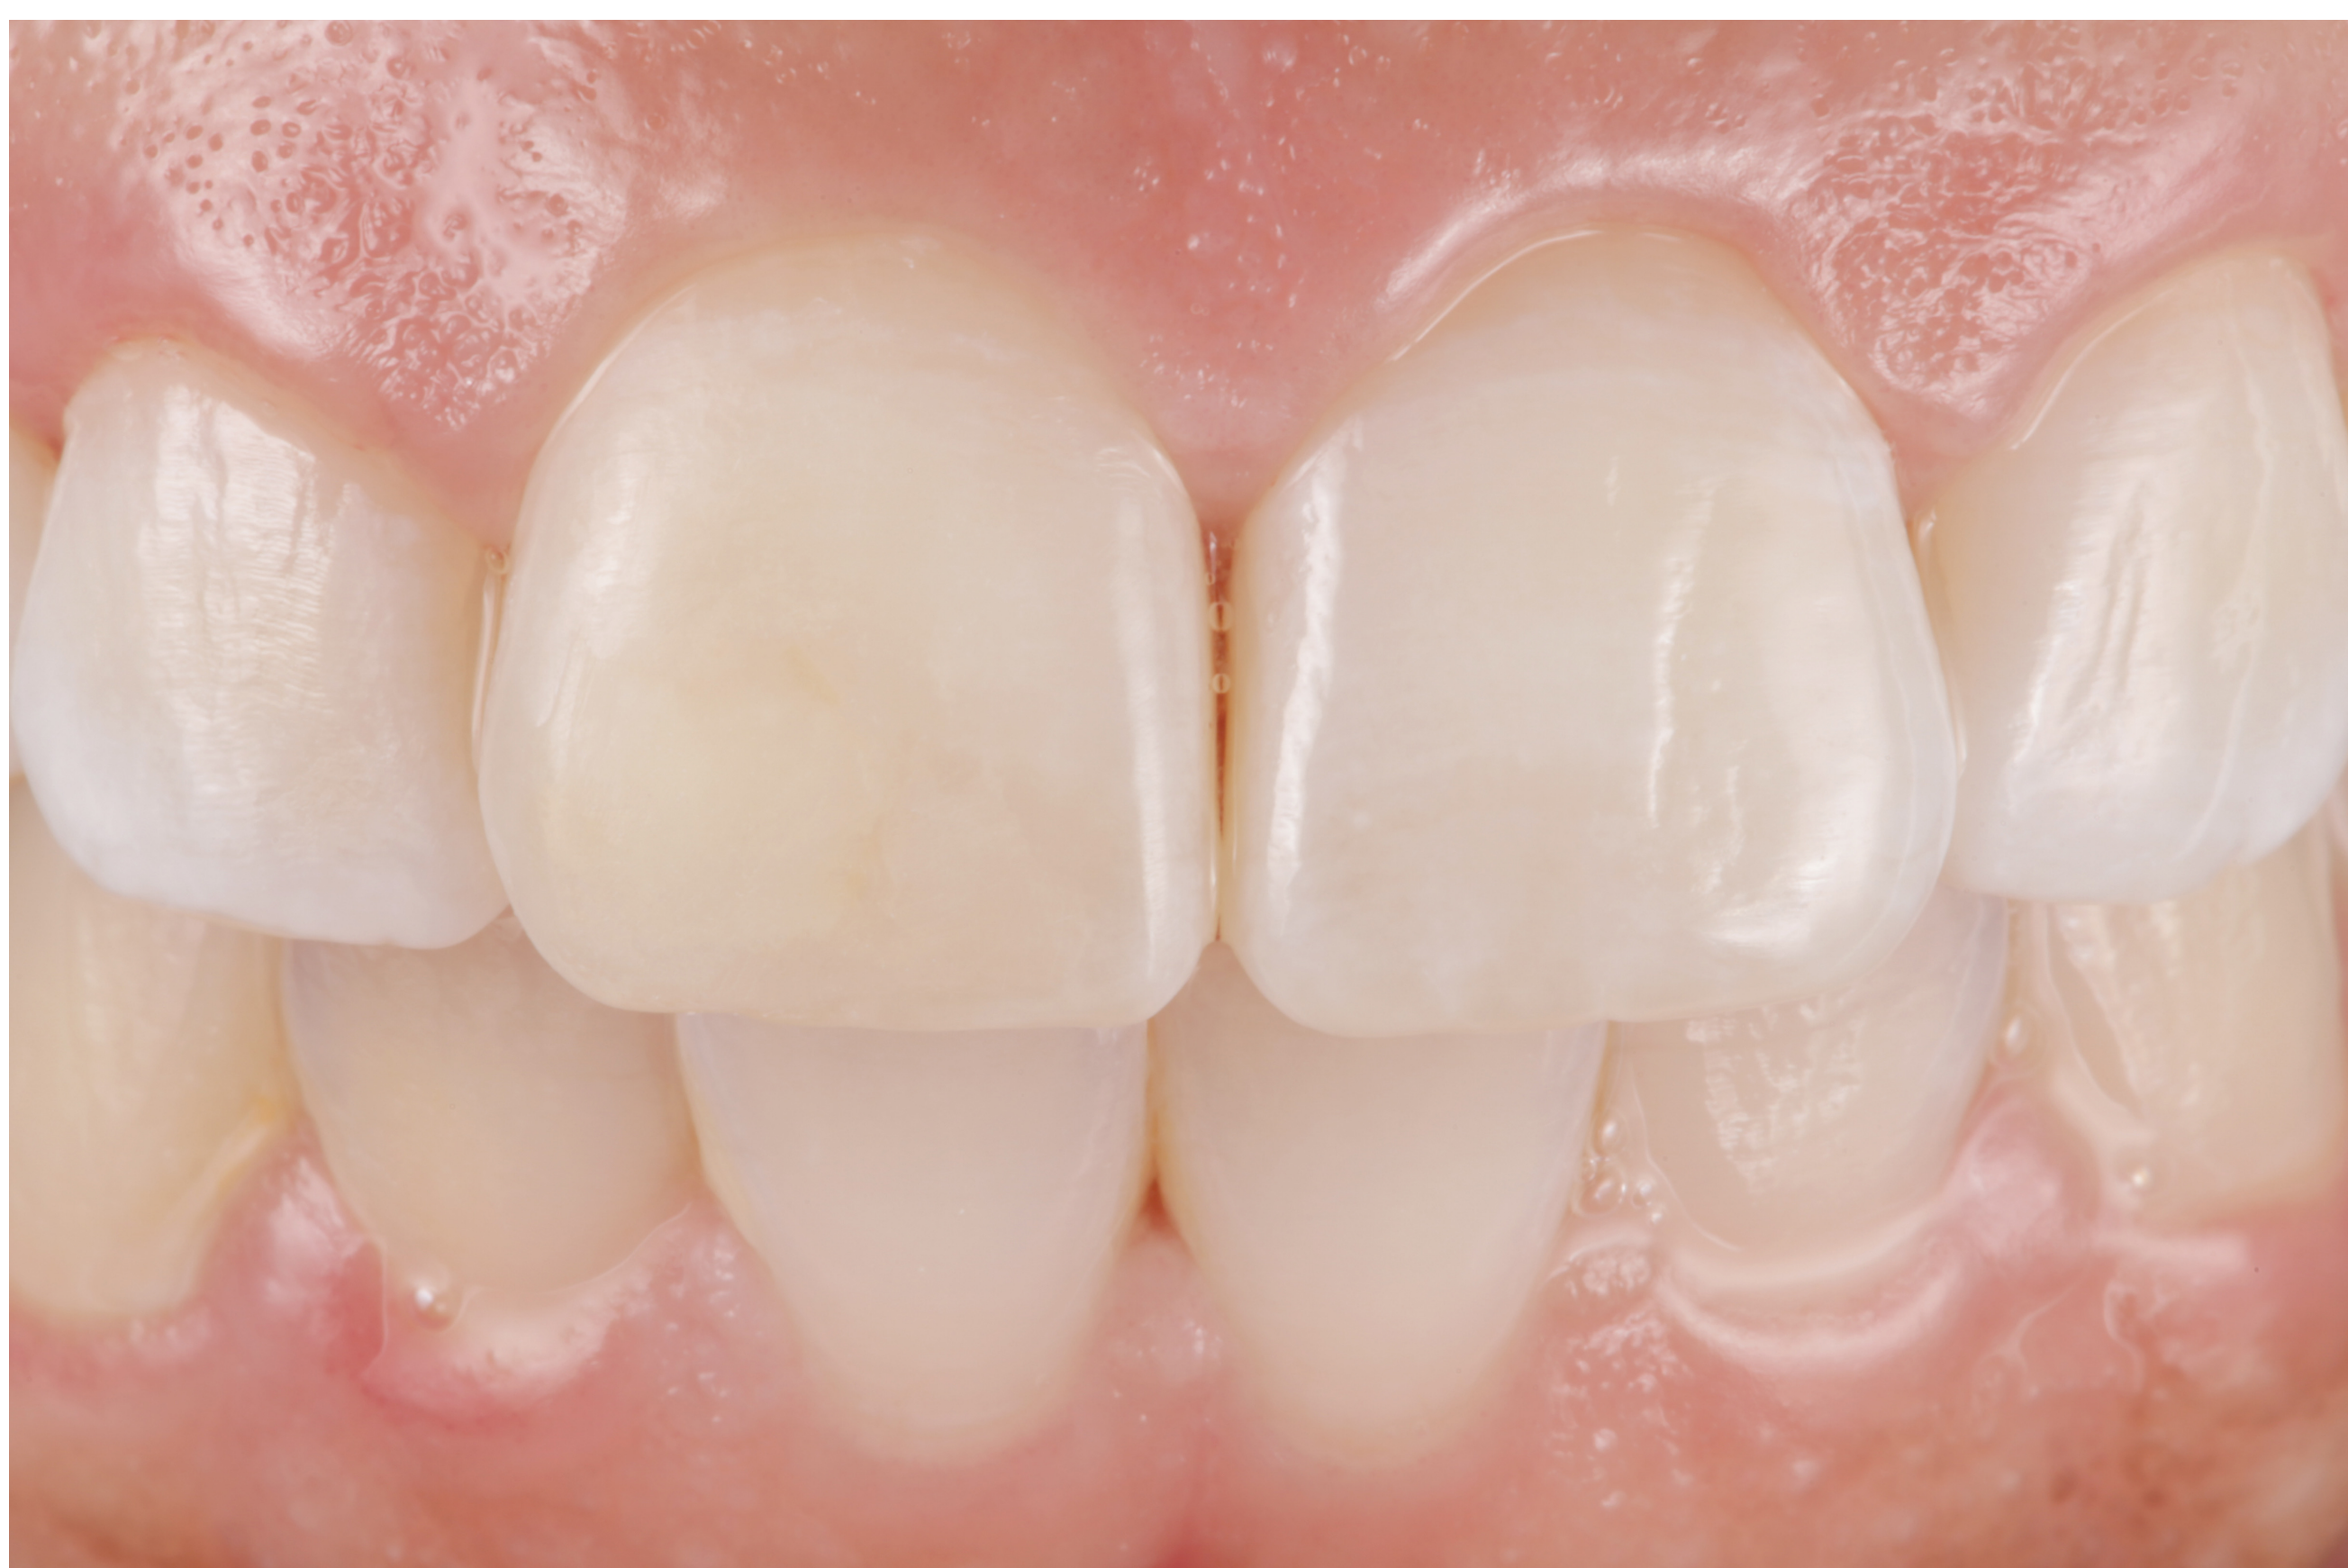
The white spot lesion showed significant reduction in appearance after treatment with resin infiltration. However, the spot was not entirely masked and the border of the original lesion can still be seen. The technique can be an effective treatment option for patients with white spot lesions. However, it is limited to shallow areas of demineralization to allow for full penetration of the infiltrant. Thus, adequate case selection is necessary for success.

Figure 2: Presentation of patient's #8 white spot lesion immediately after treatment using the resin infiltration technique.
